# WILDWOOD

## MEMORANDUM

Re: Concerns with Intersection Sight Distance – Taylor Road at  
Sandalwood Creek Drive

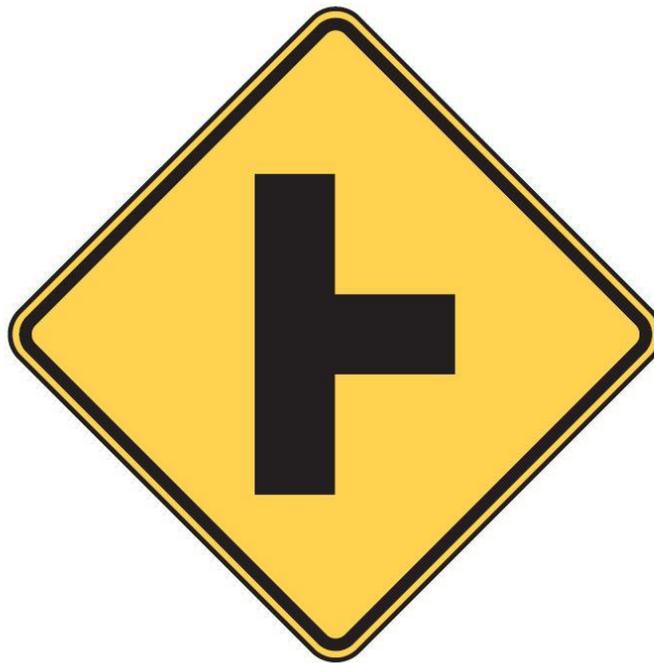
**Proposed Intersection Warning Sign**

The Department has demonstrated that that the minimum sight distance criteria has been met at this intersection for the posted speed limit of 25 MPH. However, since the criteria was not fully met to the north for the 30 MPH condition, and to the south, the sight distance is at the minimum, the Department plans to install intersection warning signs on Taylor Road approaching Sandalwood Creek Drive (see below). In addition, we recommend monitoring the intersection going forward. If it appears that motorists are having difficulties, additional measures could be considered for implementation by the Department of Public Works.

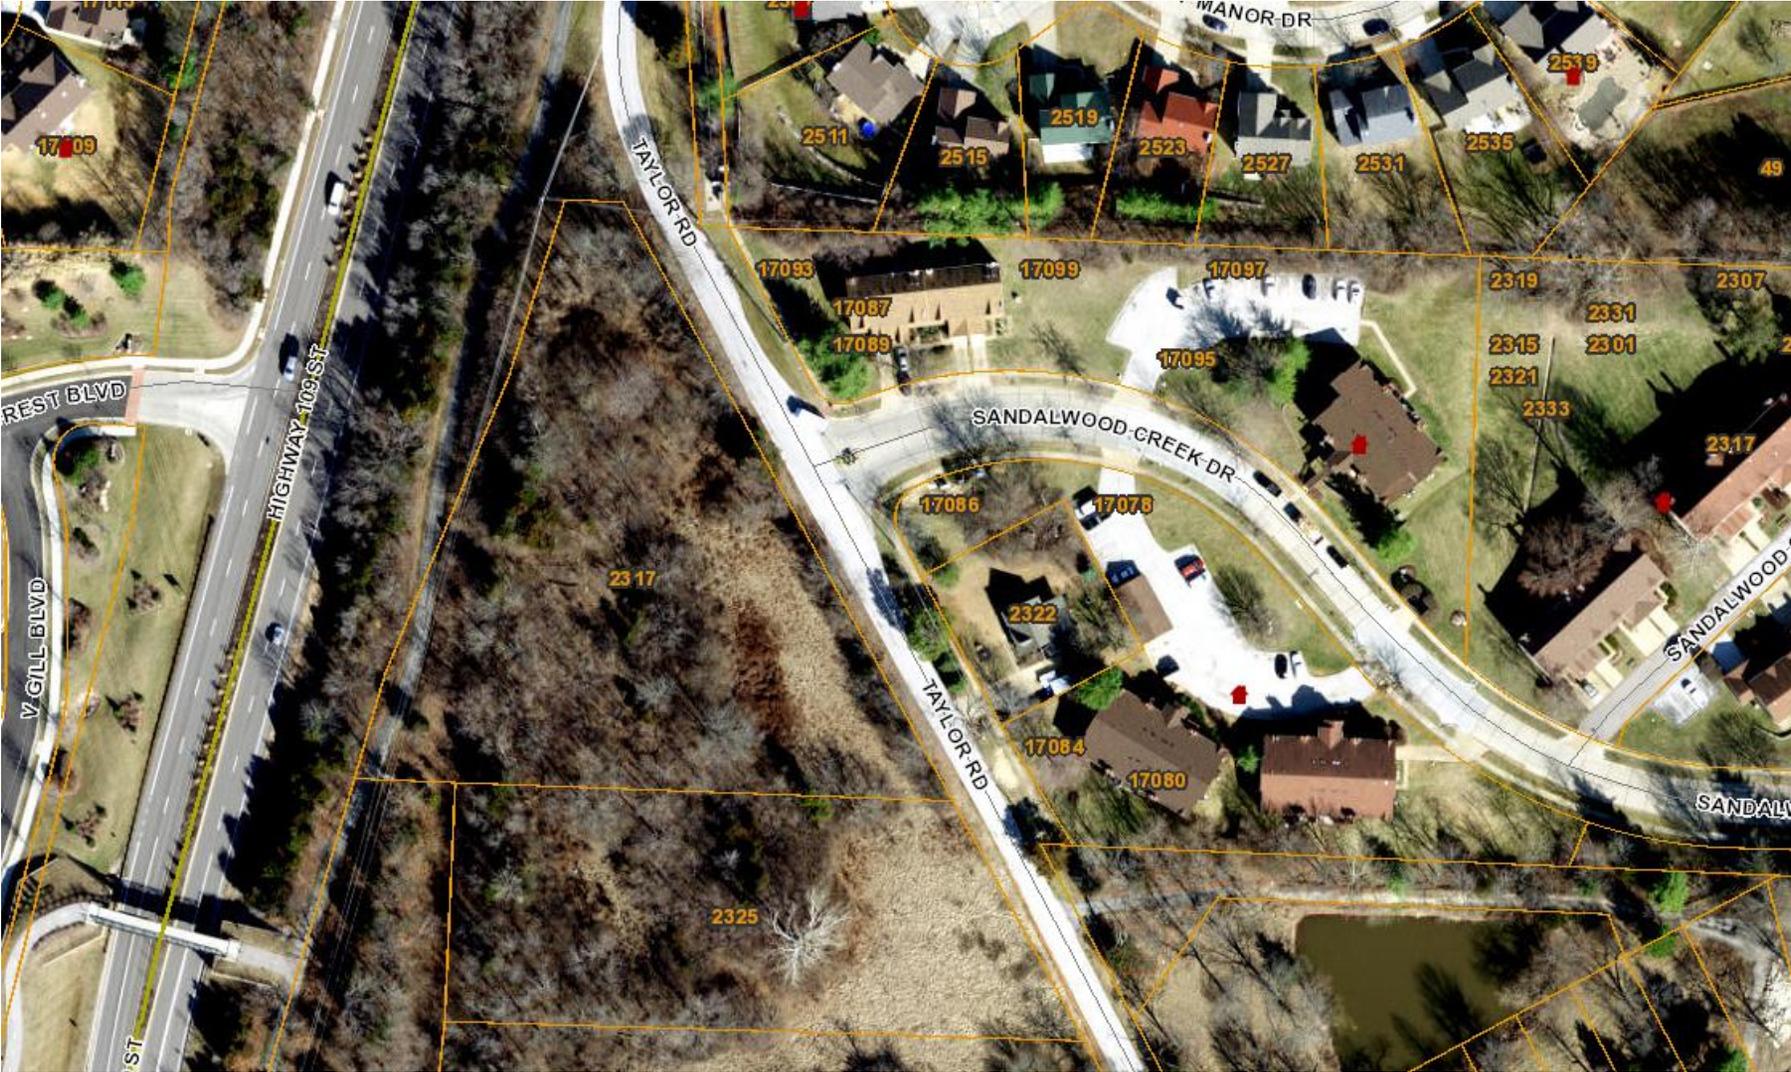
Exhibit 2: Sight Distance to the South

In response to the sight distance obstructions, the Department of Public Works reviewed the situation and requested that our tree contractor, Omni Tree Service, remove the trees which caused the obstruction to the south as well as the north. After this work was completed, the Department completed an engineering study of the intersection to determine if the available intersection sight distance complies with current engineering criteria. As Taylor Road is posted with a 25 MPH speed limit, engineering criteria dictates that a minimum sight distance of 280 feet should be provided for motorists on Sandalwood Creek Drive, turning south or north onto Taylor Road. The Department's study determined that this minimum is available to motorists. However, we recognize that some vehicles do exceed the posted speed limit, and therefore, we prefer that the intersection sight distance meets the criteria for 5 MPH above the posted speed limit, or 30 MPH which equates to 335 feet. Based on our field study, the intersection does meet this requirement to the south. To the north, however, we do not meet this specification, as the sight distance was measured to be 318 feet, just less than 335 feet. To help visualize this, please see the sight distance photos attached as **Exhibits 2 and 3**.
